**WIRE-MESH
PRODUCTS, INC.**
BECAUSE A BELT IS NOT JUST A BELT™

CASE STUDY

CHAIN BELT FAILURE

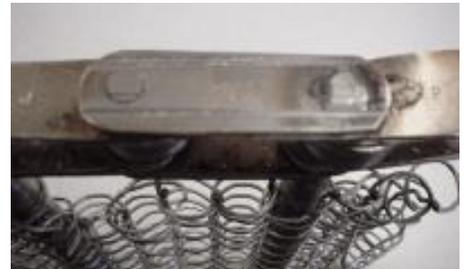
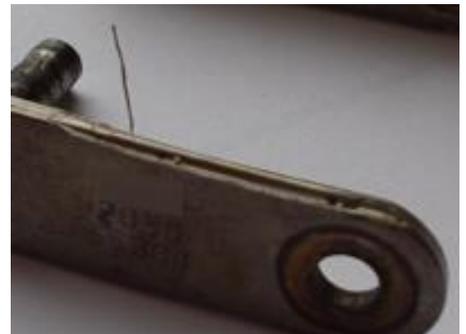
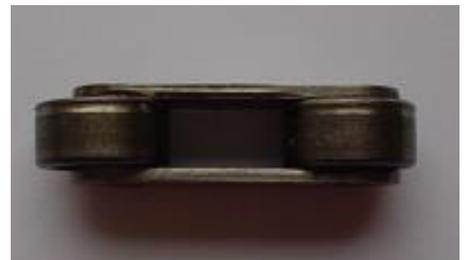
A C2052 riveted 304 series stainless steel chain belt was sent to Wire-Mesh for an inspection report due to premature failure. WMP received two strands, one assembled on the wire mesh belt and the other disassembled from the other side of the wire mesh belt.

The chain showed multiple reasons for the failure. Inspection showed signs of excessive wear and no lubrication combined with severe overloading, far exceeding its maximum allowable load. This was evident from the galling on the pins and rollers. Pin link plates and rollers also showed signs of damage caused by a mechanical interference.

Wire-Mesh recommended increasing the chain size to match the load, keeping the chain well lubricated, executing frequent inspections of all chain guards for unwanted contact with the chain, and ensuring all sprockets are matched and paired. Support rod deflection engineering was checked as was the journaling technique. Many quality levels of chain exist, and WMP chooses those at the highest level (e.g. solid bushings and solid rollers among many others) as their standard.
