**WIRE-MESH
PRODUCTS, INC.**
BECAUSE A BELT IS NOT JUST A BELT™

CASE STUDY

POORLY TRACKING BELT

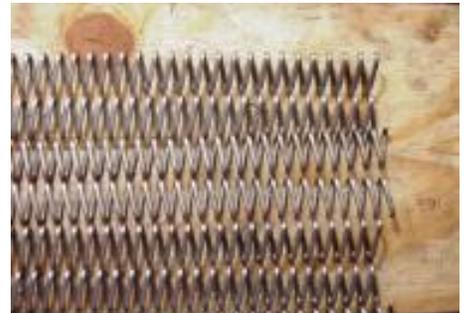
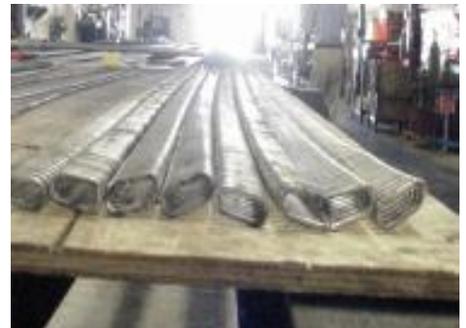
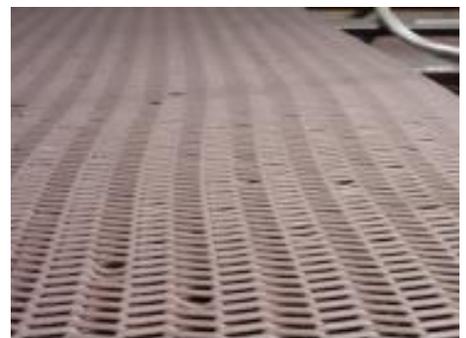
Wire-Mesh performed a five-step analysis on the damaged belt and found several contributing factors to its failure. Reasons for the failure included spiral run-out, spiral twist, uneven pressure, mismatch between spiral and crimp, mechanical damage, and a high spiral profile. All of these factors played a significant role towards premature belt failure, excess stretch and camber, stress concentration points, difficulty in splicing, and tracking problems.

Wire-Mesh proposed a low-spiral profile technology belt solution manufactured under rigid quality control systems, resulting in a high performing belt which outlasted and outperformed the current belt, ultimately financially benefitting the company.
